# ASBESTOS SURVEY REPORT

PUT-CR O-14.74 (PID 117598)

County Road O Bridge Structure (SFN: 6932533)  
over Cranberry Run, Pandora, Ohio 45877

Putnam County Engineer  
Ohio Department of Transportation District 01  
May 08, 2023

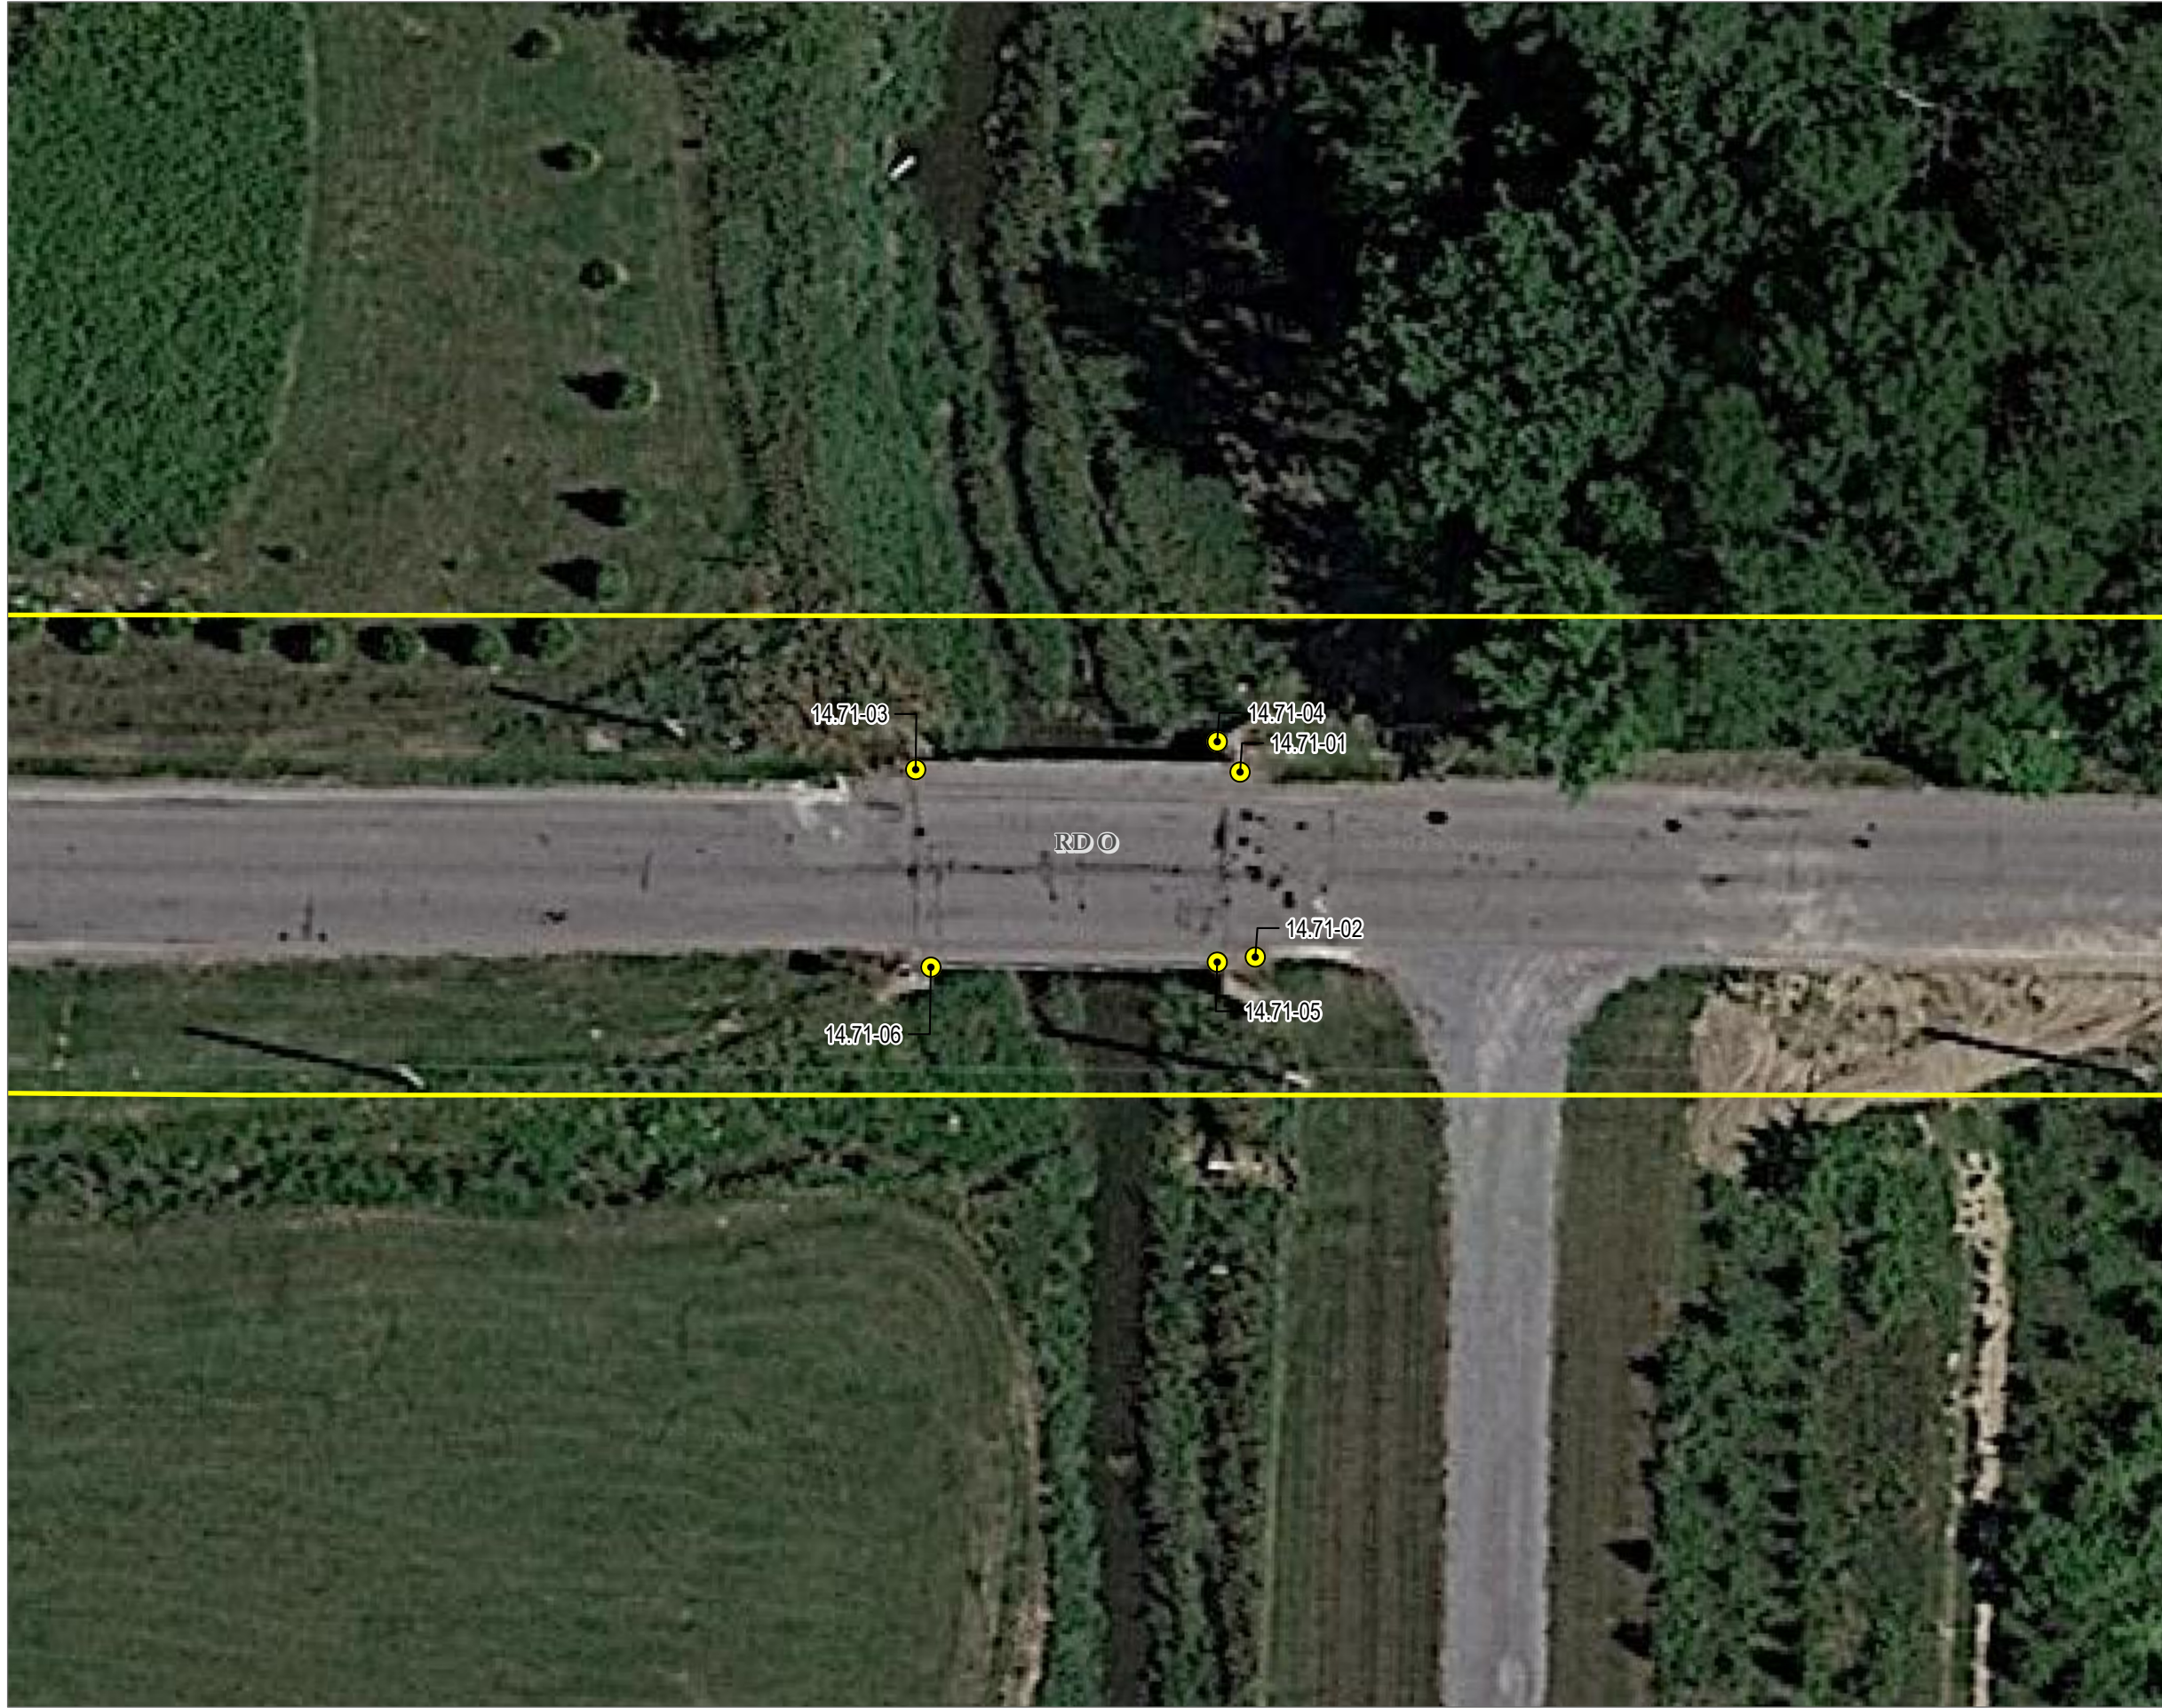
**APPENDIX B**  
**SITE FIGURE**

- PROJECT STUDY AREA
- SAMPLE LOCATIONS

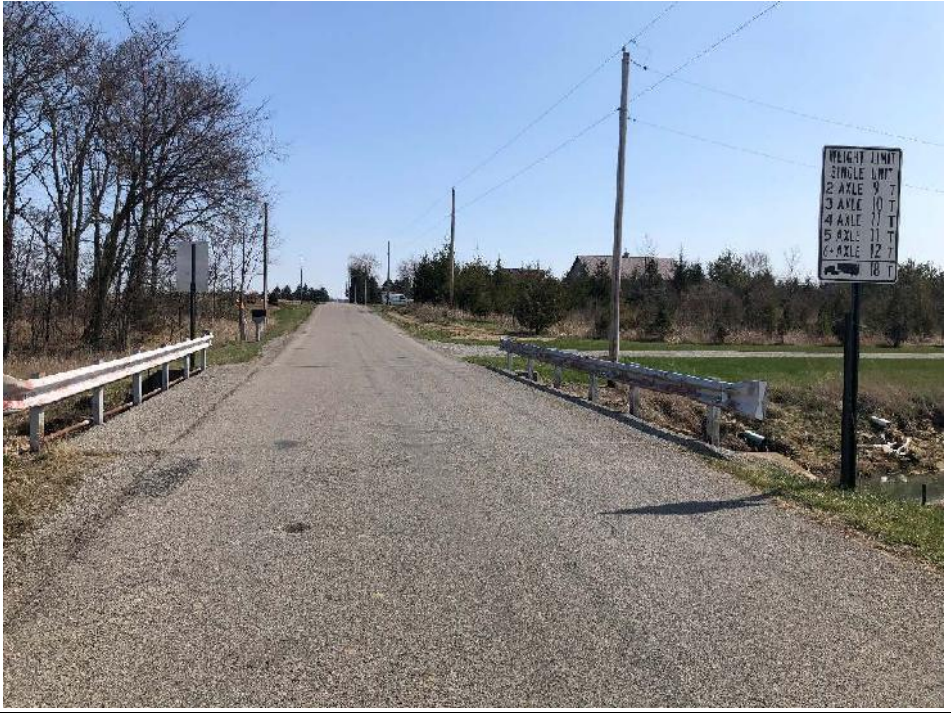
<b>Client Name:</b> Putnam County Engineer & Ohio Department of Transportation		<b>Site Location:</b> County Road O Over Cranberry Run, Pandora, Ohio 44877	<b>Project No.:</b> 422727.0014
<b>Photo No.</b> 1	<b>Date</b> March 30, 2023

<b>Description:</b> View of the bridge deck on County Road O, facing east.

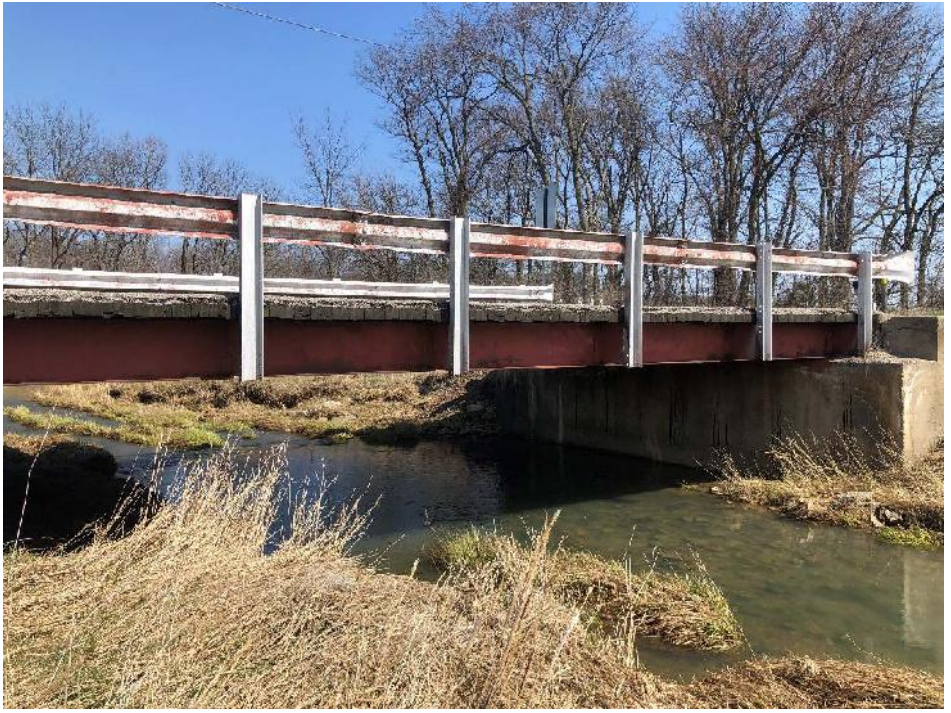
<b>Photo No.</b> 2	<b>Date</b> March 30, 2023

<b>Description:</b> View of bridge structure over Cranberry Run, facing northeast.

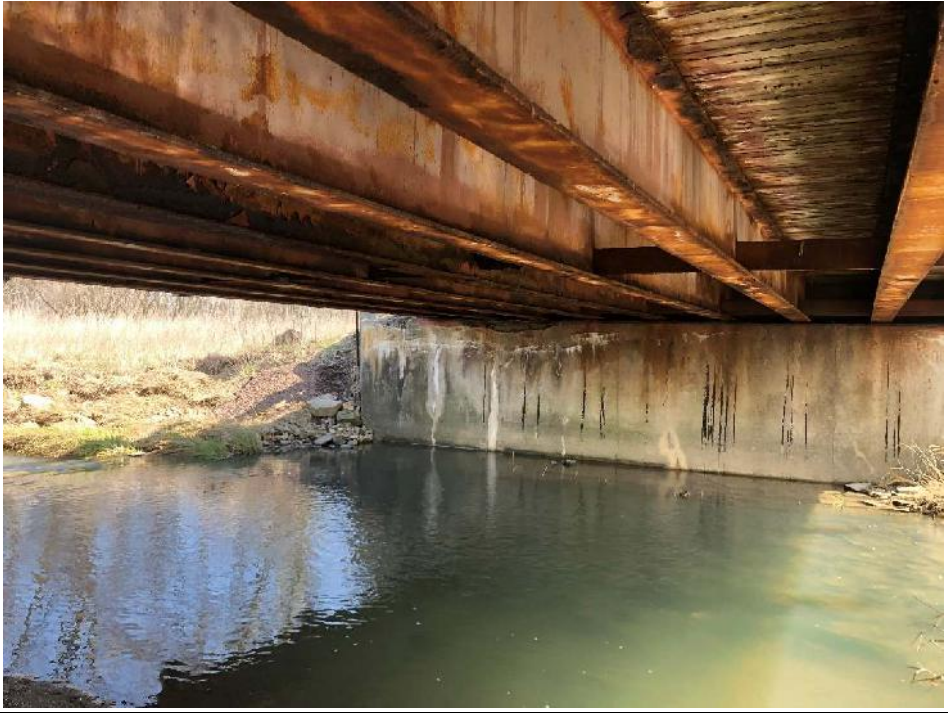
<b>Client Name:</b> Putnam County Engineer & Ohio Department of Transportation		<b>Site Location:</b> County Road O Over Cranberry Run, Pandora, Ohio 44877	<b>Project No.:</b> 422727.0014
<b>Photo No.</b> 3	<b>Date</b> March 30, 2023

<b>Description:</b> Underside view of bridge deck over Cranberry Run, facing northeast.

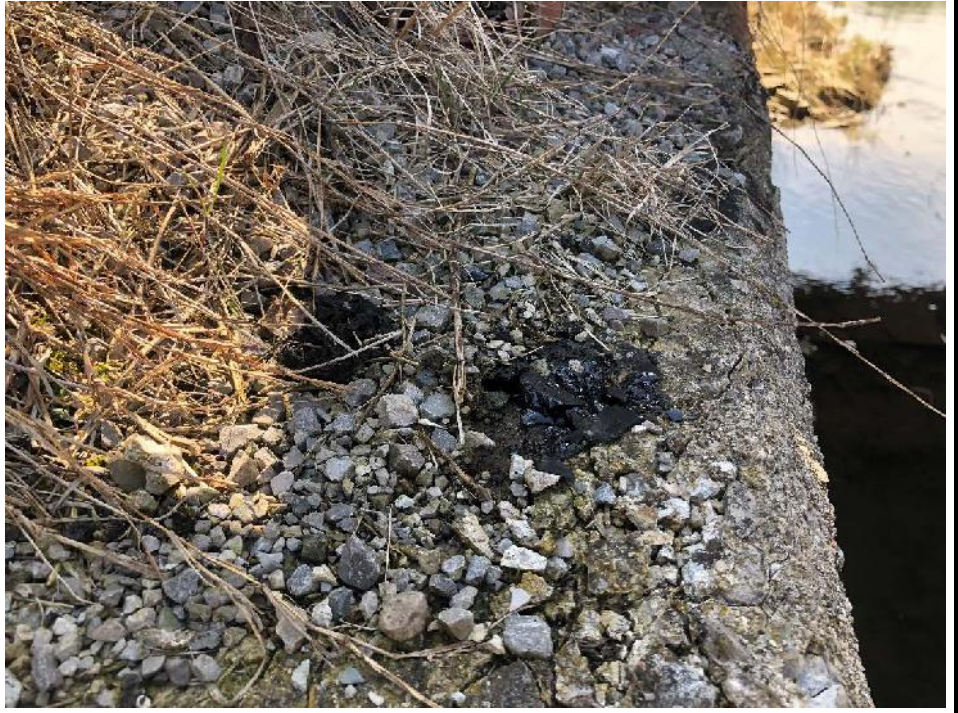
<b>Client Name:</b> Putnam County Engineer & Ohio Department of Transportation		<b>Site Location:</b> County Road O Over Cranberry Run, Pandora, Ohio 44877	<b>Project No.:</b> 422727.0014
<b>Photo No.</b> 5	<b>Date</b> March 30, 2023

Bridge Structure PUT-CR 0-14.74							
Sample Number	Material	Sample Location(s)	Percentage / Type of Asbestos	Approx. Quantity	Condition	Type	NESHAP Category
14.71-04 14.71-05 14.71-06	Black Asphalt Tar	Northeast Side of the Bridge Abutment	ND	891 SF	Good	NA	NA

<b>Description:</b> View of sample material 14.71-04 – 06: black tar asphalt, located on bridge abutments, facing south.
